LTPP Seasonal Monitoring Program

Site Installation and Initial Data Collection Section 510114, Danville Virginia

Report No. FHWA-TS-96-51-02

Pavement Management Systems Limited 415 Lawrence Bell Drive - Suite 3 Amherst, New York 14221

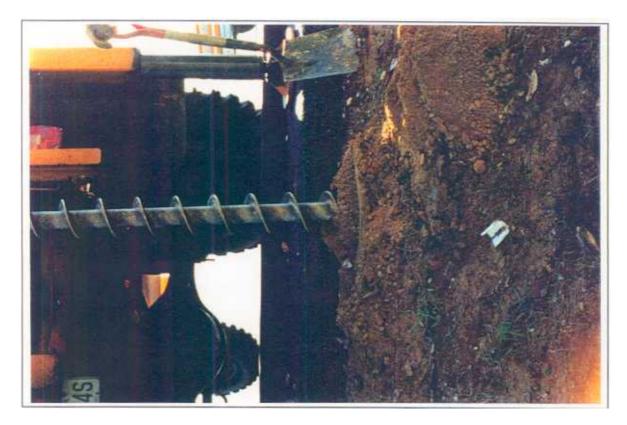
Figure F. Augering Piezometer Hole

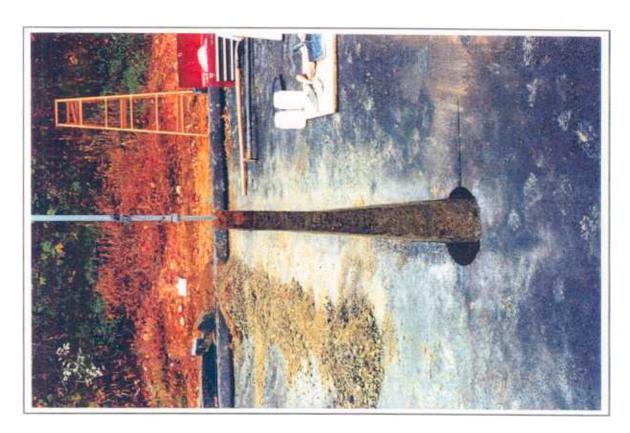
Figure E-3. Instrument Hole and Trench Area - Before Augering Instrument Hole

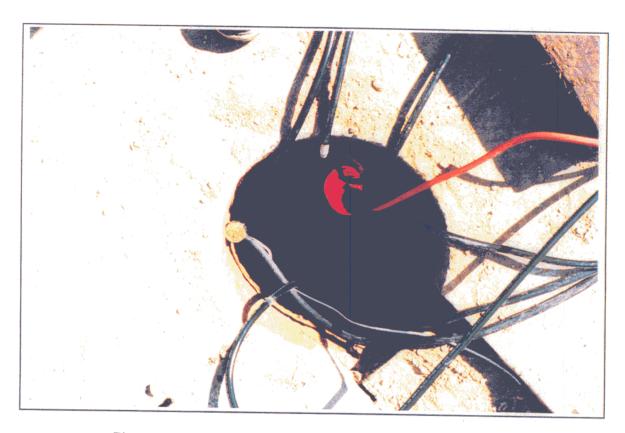
Figure E-5. Compacting Instrument Hole at TDR #5 Location

The instrumentation hole and trench were repaired by placing and compacting hot-mix asphalt concrete. The VDOT personnel filled and compacted the hot-mix on October 25, 1995. Soil cover of at least 50 mm was maintained over the conduit for the extent of the paved trench. The road base material removed from the trench was used to bring it up to grade. The chunks of asphalt removed from the pavement were cleared by the VDOT personnel on October 25, 1995.

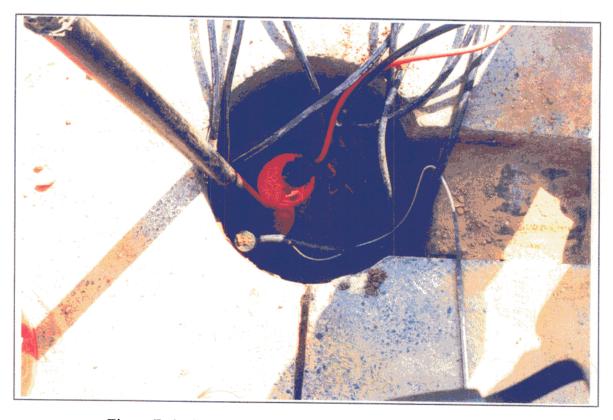
Figure E-6. Compacting Instrument Hole at TDR #3 Location
